NATIONAL PROGRAM FOR INSPECTION OF NON-FEDERAL DAMS
MOLCOTT DAM (VT 00179) (U) CORPS OF ENGINEERS WALTHAM
MA NEW ENGLAND DIV JUN 80

WOLCOTT DAM VT 00179

DOCUMENT IDENTIFICATION
JUNE 1980

Wolcott Dam - VT 00179
Wolcott, Vermont
May 6, 1980

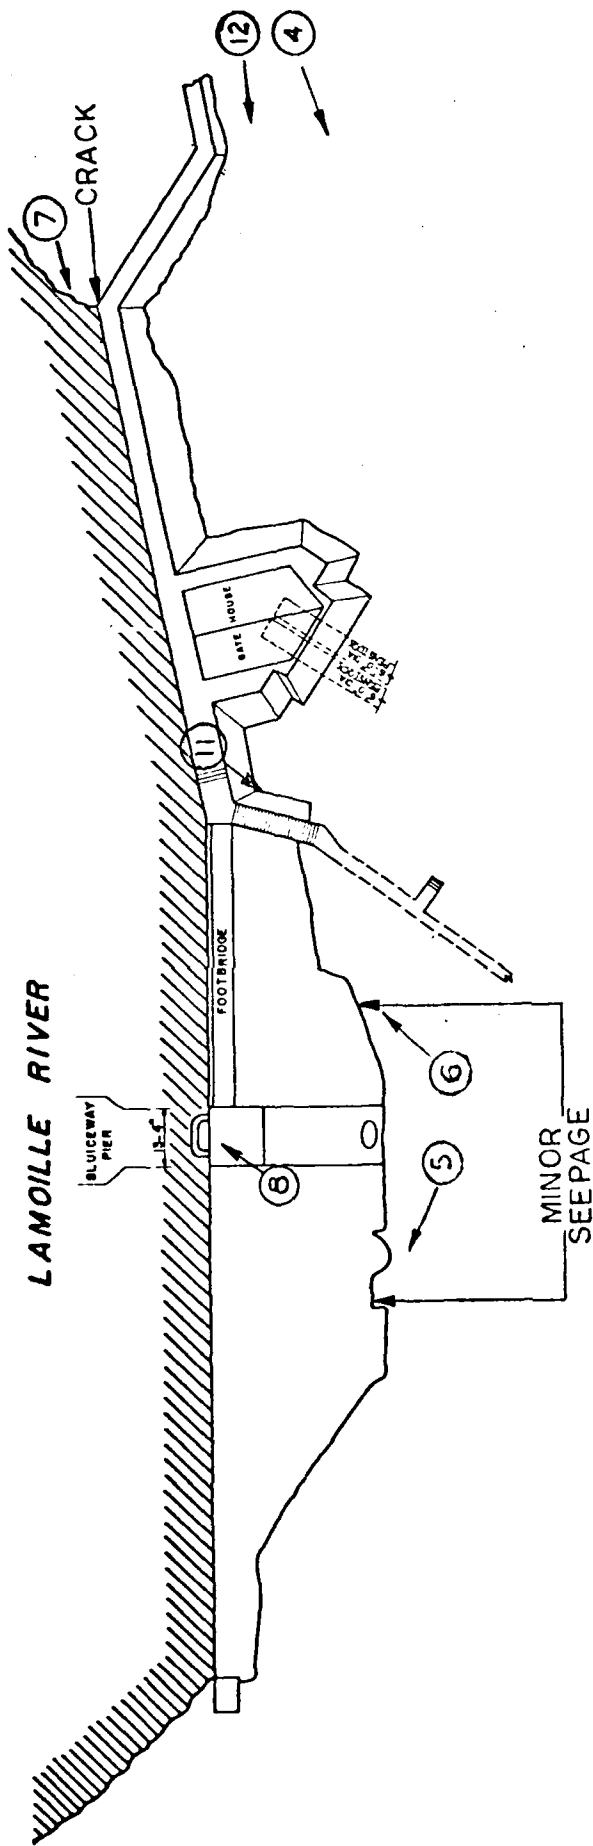
PHOTO LOCATION PLAN
WOLCOTT DAM

⑨ AND ⑩ TAKEN AT DIKE AT REAR OF IMPOUNDMENT

⑬ TAKEN DOWNSTREAM
→

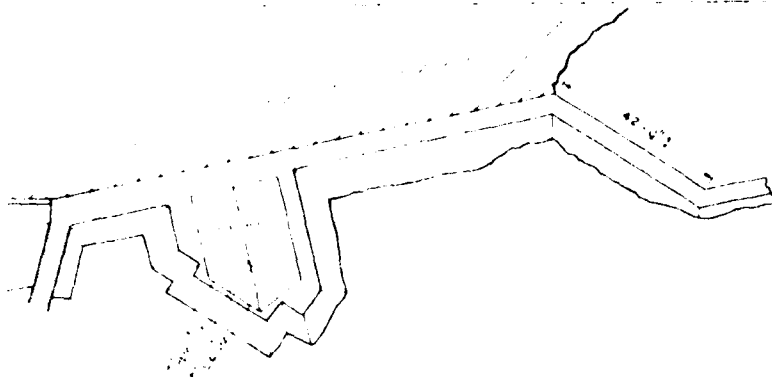
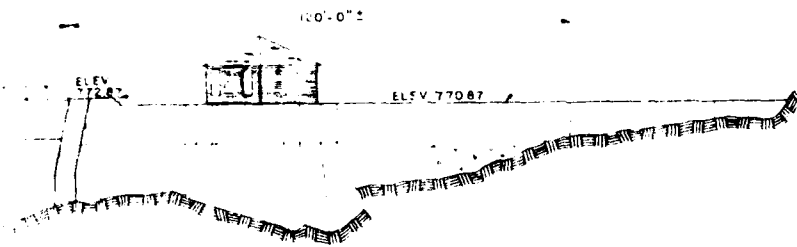
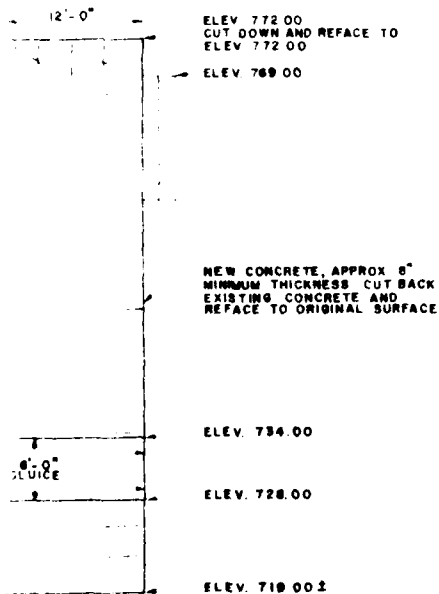
1A
SHEET 16

NOTE:
THIS PLAN COMPILED FROM EXISTING
PLANS FOR THE DAM RECONSTRUCTION
IN 1946, BY CHAS. T. MAIN, INC.,
ENGINEERS, AND MODIFIED AS OBSERVED
IN THE FIELD.
